## **NATIONAL TRANSPORTATION SAFETY BOARD**

### **Group Chairman's Factual Report**

# **METEOROLOGY**

**DCA13MA120**

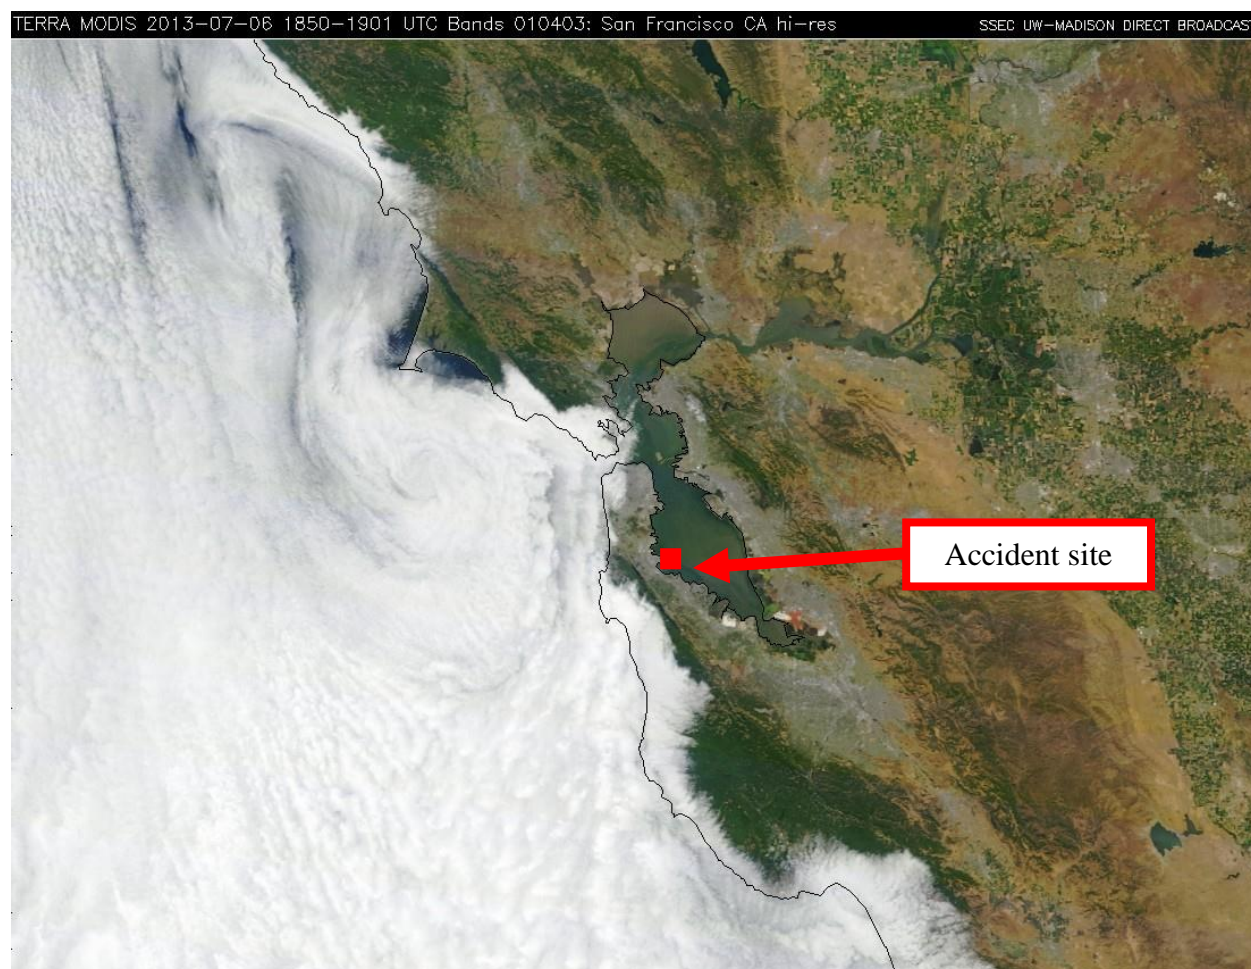
Visible data from NASA's Terra satellite and Moderate Resolution Imaging Spectroradiometer (MODIS) was obtained from the Space Science and Engineering Center (SSEC) at the University of Wisconsin-Madison. Figure 11 presents a true color<sup>13</sup> MODIS image from 1150 PDT of western California with the accident location highlighted. The area of clouds is visible west of the accident site.

**Figure 11 – MODIS true color image at 1150 PDT**

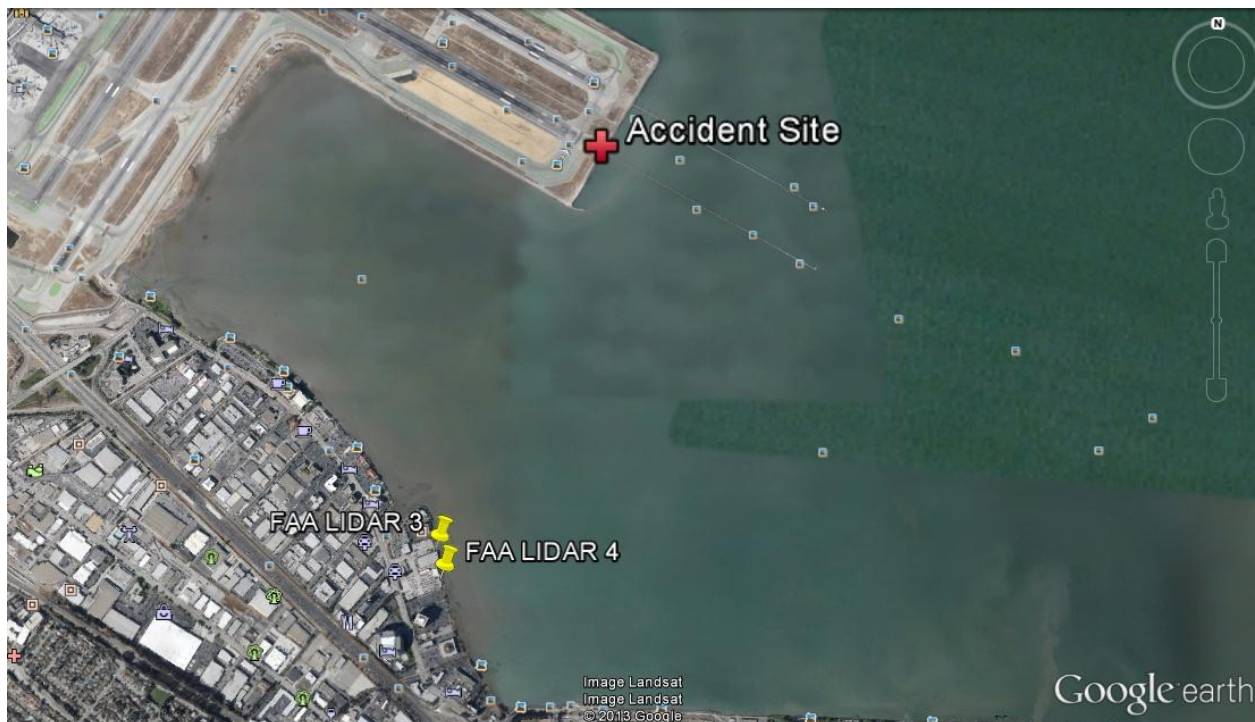
Two FAA Light Detection and Ranging (LIDAR) sensors were located close to the accident site (figure 13). Wind data from these LIDARs was captured around the accident time and is listed below (tables 5 through 8):

**Figure 13 – Position of FAA LIDAR sensors relative to the accident site**

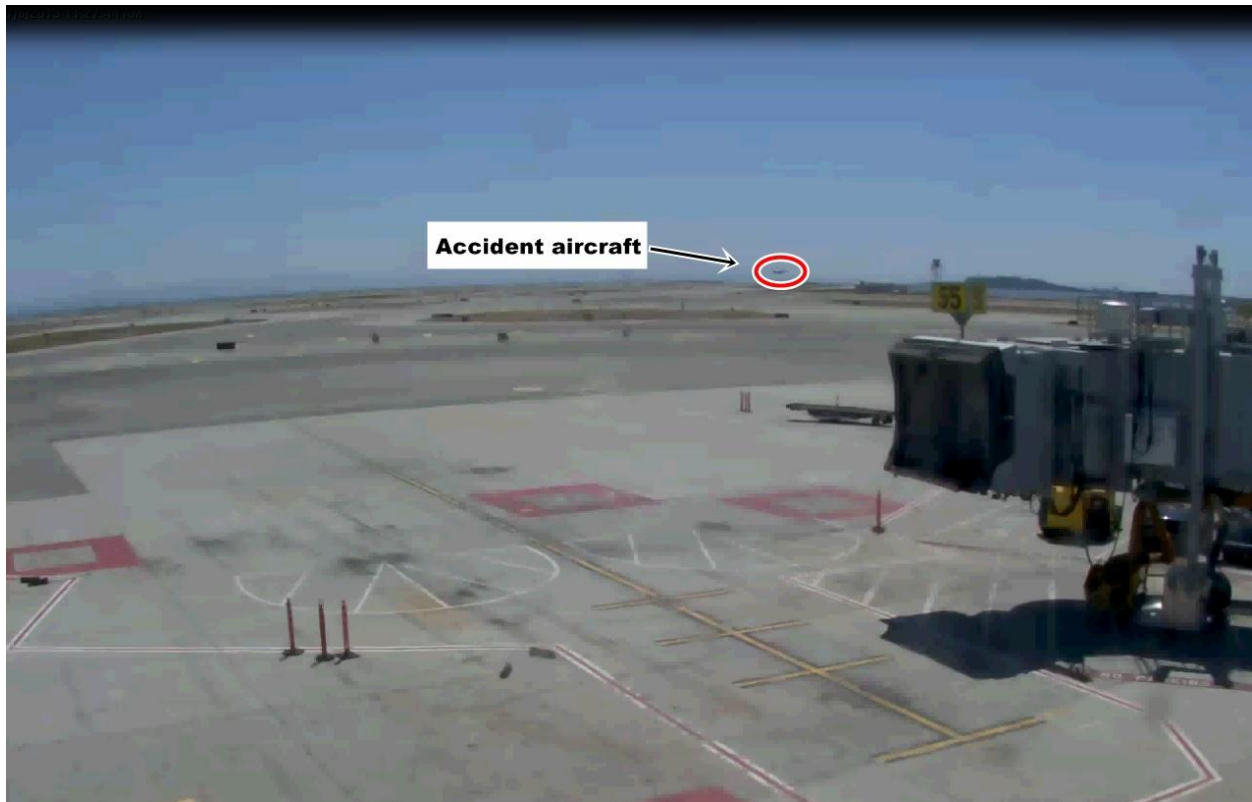
A camera located near the KSFO terminal was recording and had images from around the accident time. Figure 15 reveals an image of the accident aircraft while on final just above the runway. None of the few clouds at 1,600 feet agl reported from KSFO (section 3.0) were located on final approach or near the east end of the KSFO airport.

**Figure 15 – Image from a camera near the KSFO terminal just before the accident time**
